Thameslink Programme Electrification & Signalling Interface Issues

Martin Sigrist – Principal Design Engineer (E&P)

Date 28-01-2014

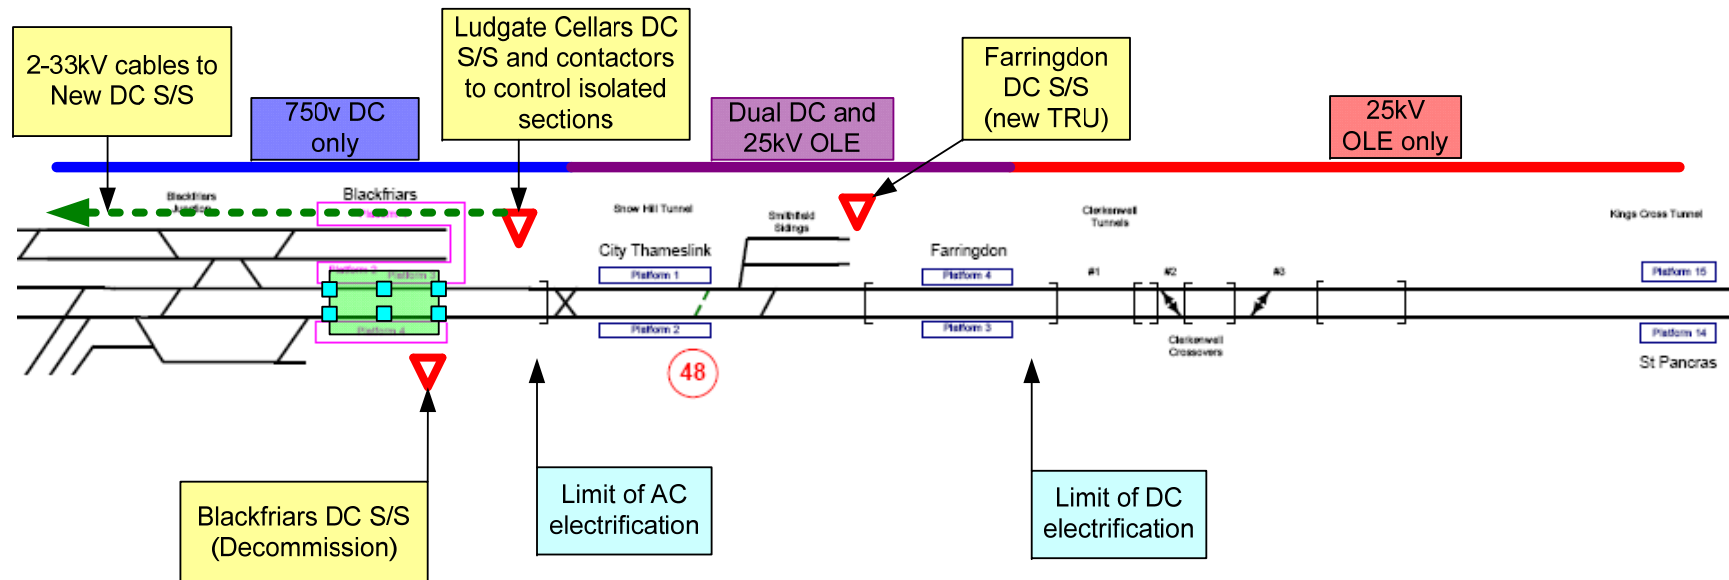
- New layout between Farringdon and Blackfriars with an extended DEA and 12 Car Contactor Section

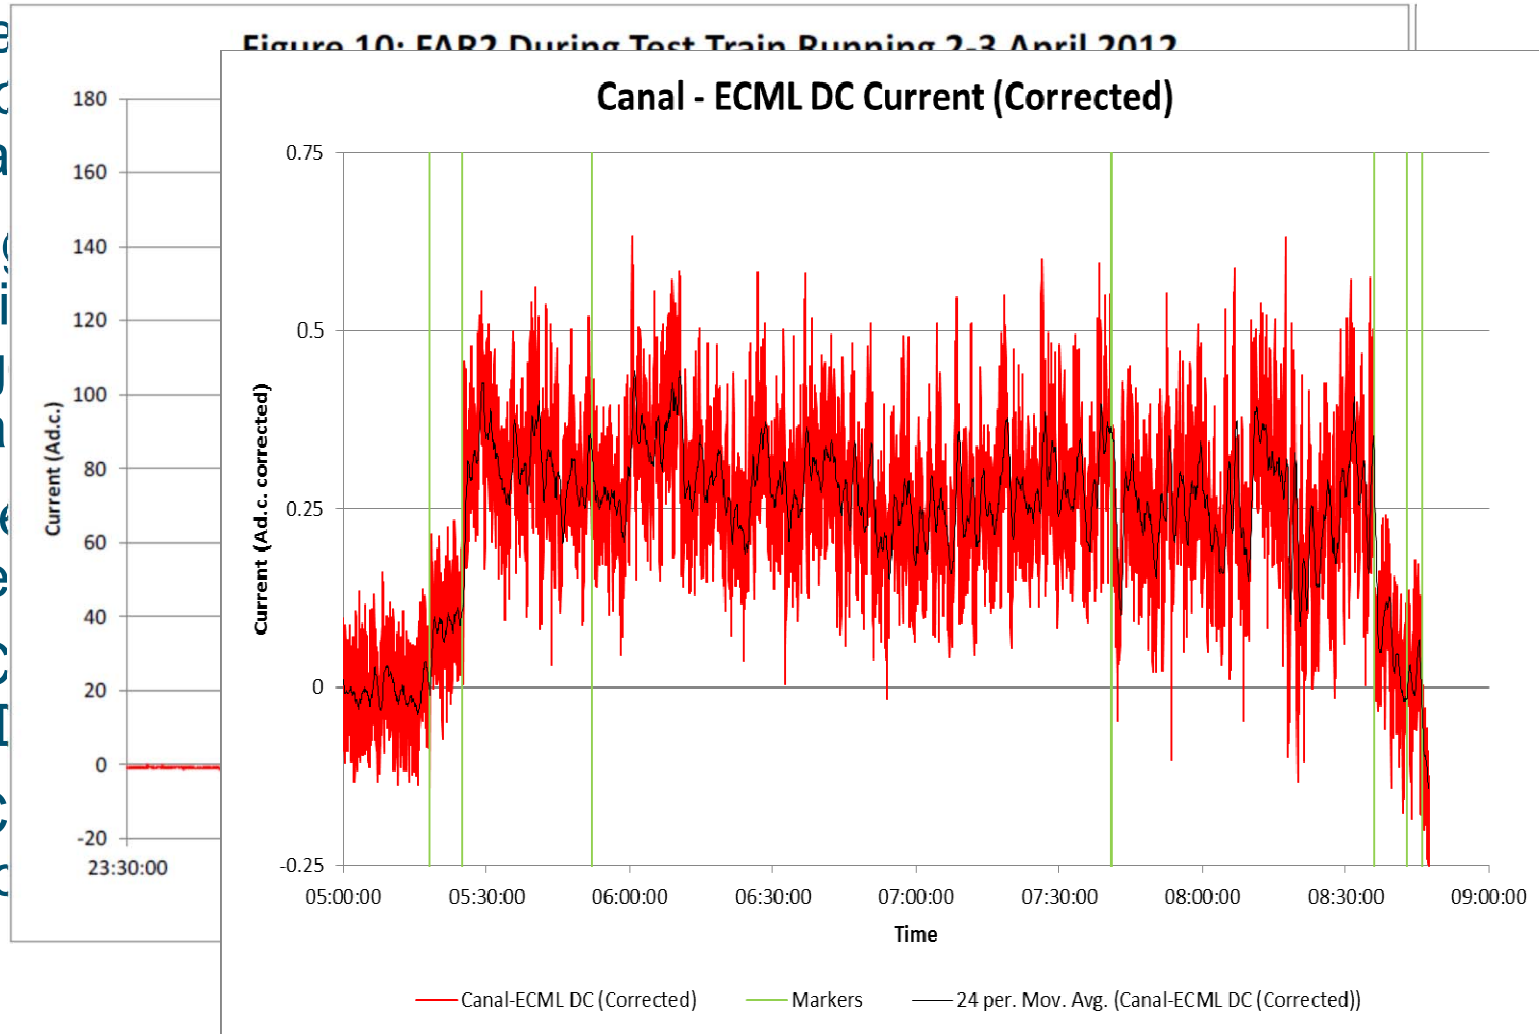
- Further stray current at interface
- Testing the drift change time constant
- An interface will be
 - DC to DC
 - AC to AC

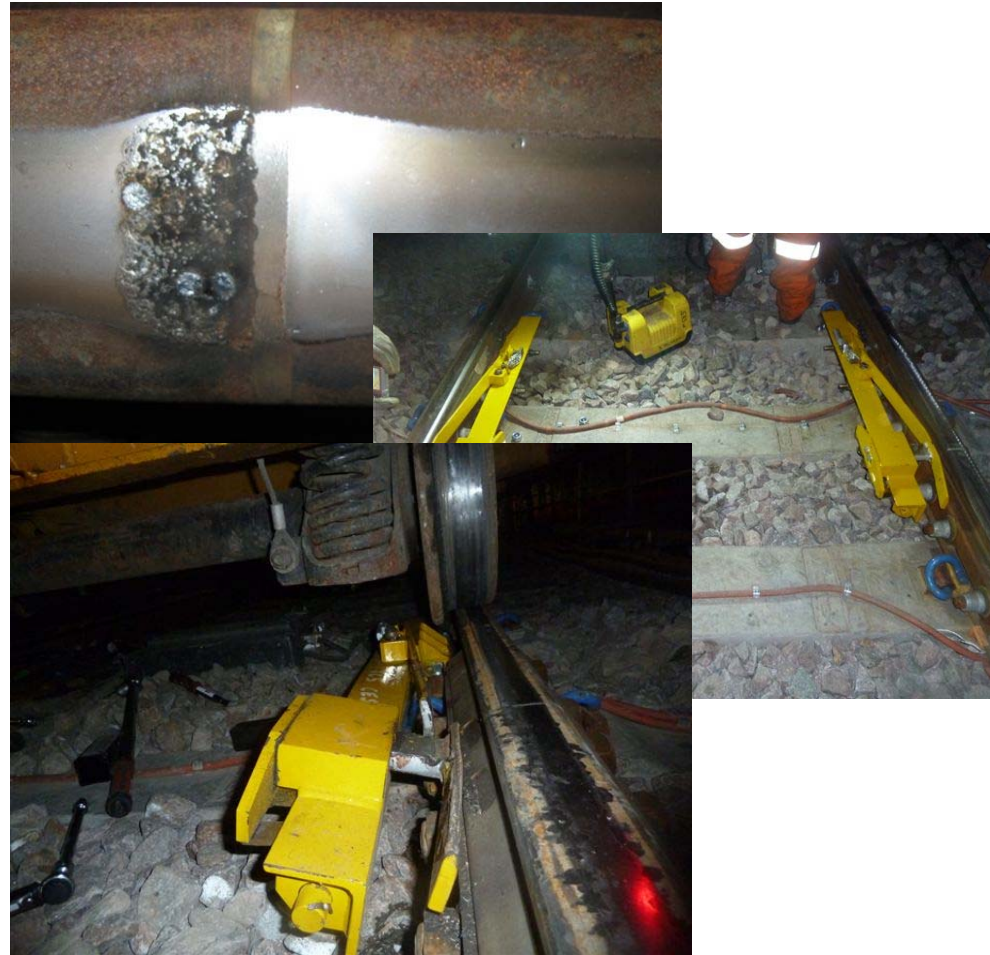
- IRJ Arcing?
- Not considered or known about during the initial design
- Currently being monitored and assessed
- Four solutions being investigated, including arc diverters and contactors installed closer to the IRJ
- Arc Diverter in Operation

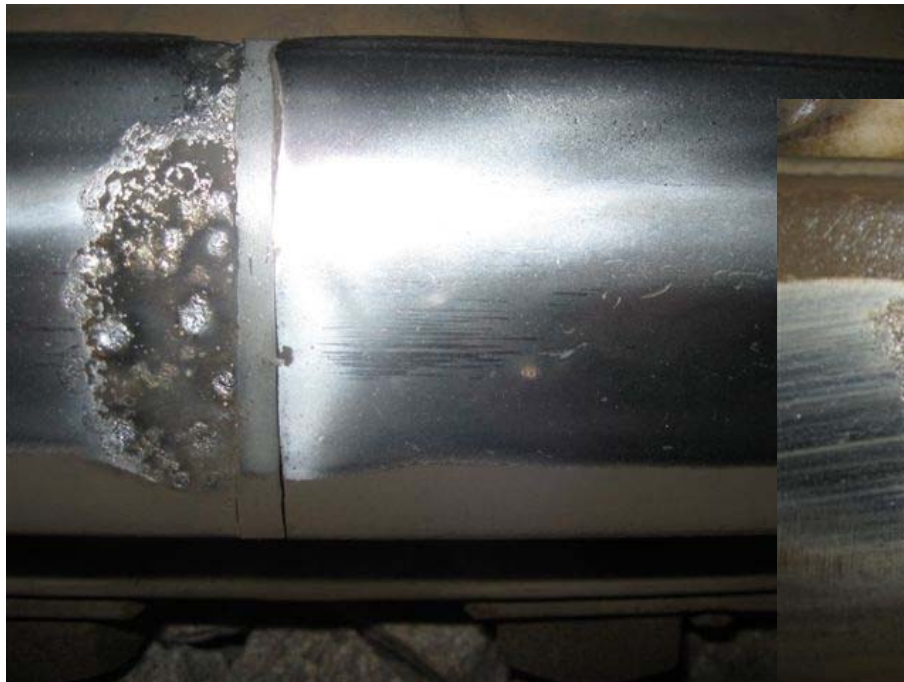
Before

- What happens to IRJ arcing when cables are shorten?

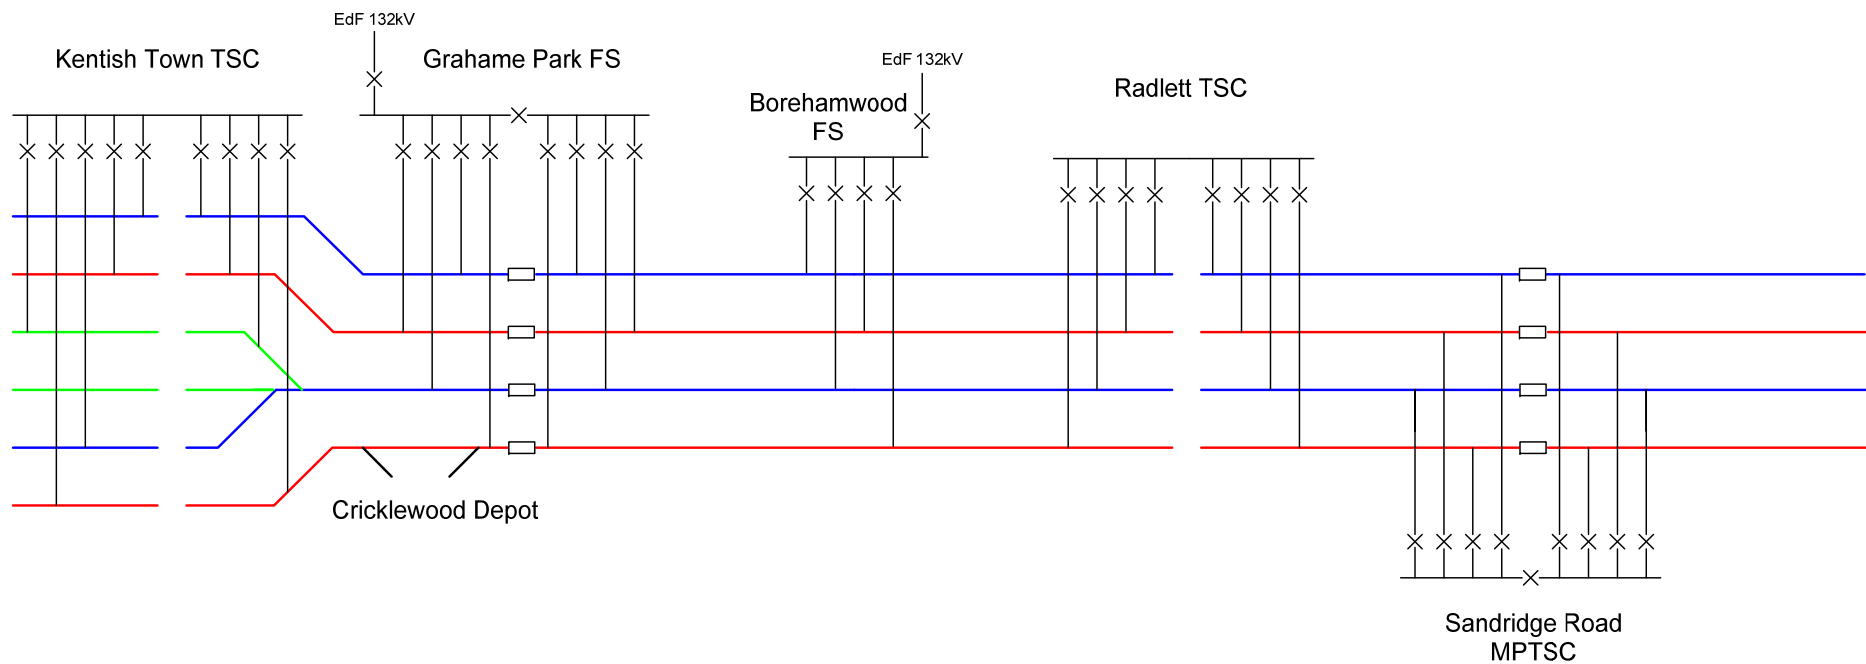
- Overview of the 25kV Classic fed system on the MML, with convention bonding

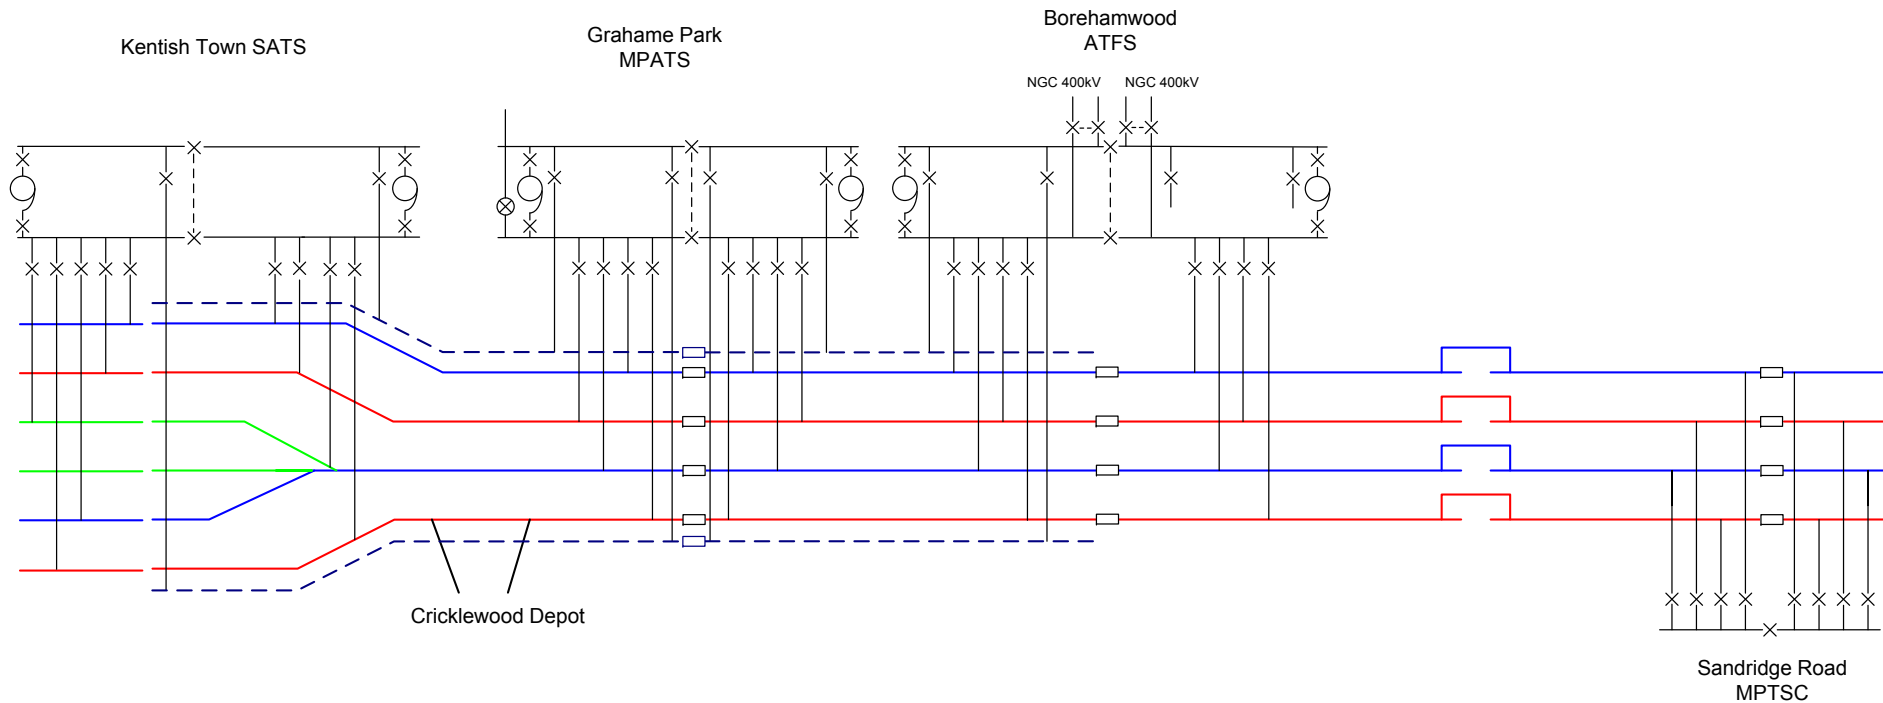
- Overview of the TLP Autotransformer Upgrade Scheme on the MML, which required enhanced bonding over the complete length

- The Thameslink Autotransformer installation was broken down into 7 key stages, these are:
 - Stage 1 = Install Return Screen Conductor (RSC) & additional Cross Track Bonding (XTB)
 - Stage 2 = Switchgear Renewal
 - Stage 3 = Remove BT/RC System
 - Stage 4 = 1st National Grid (NG) feed installed and commissioned
 - Stage 5 = Borehamwood neutral section
 - Stage 6 = Full AT System
 - Stage 7 = 2nd NG feed installed and commissioned

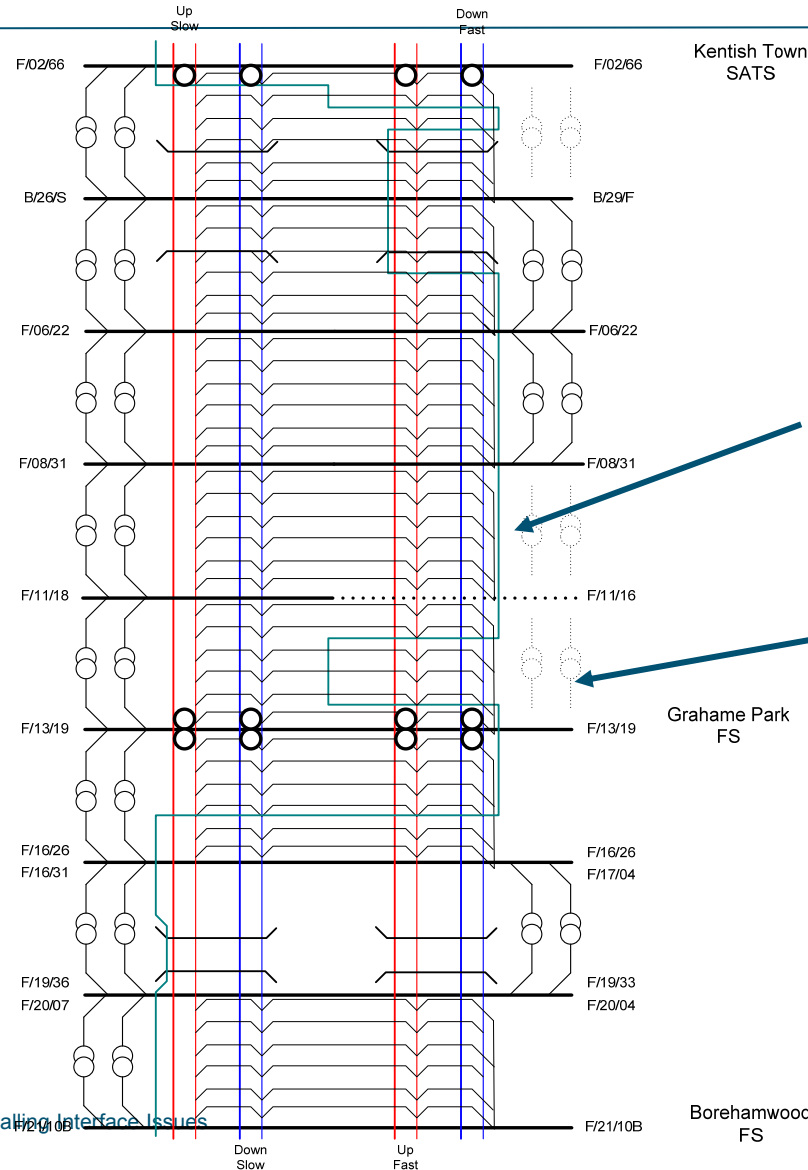
Each section defined between Mid-Point Connections (MPCs)

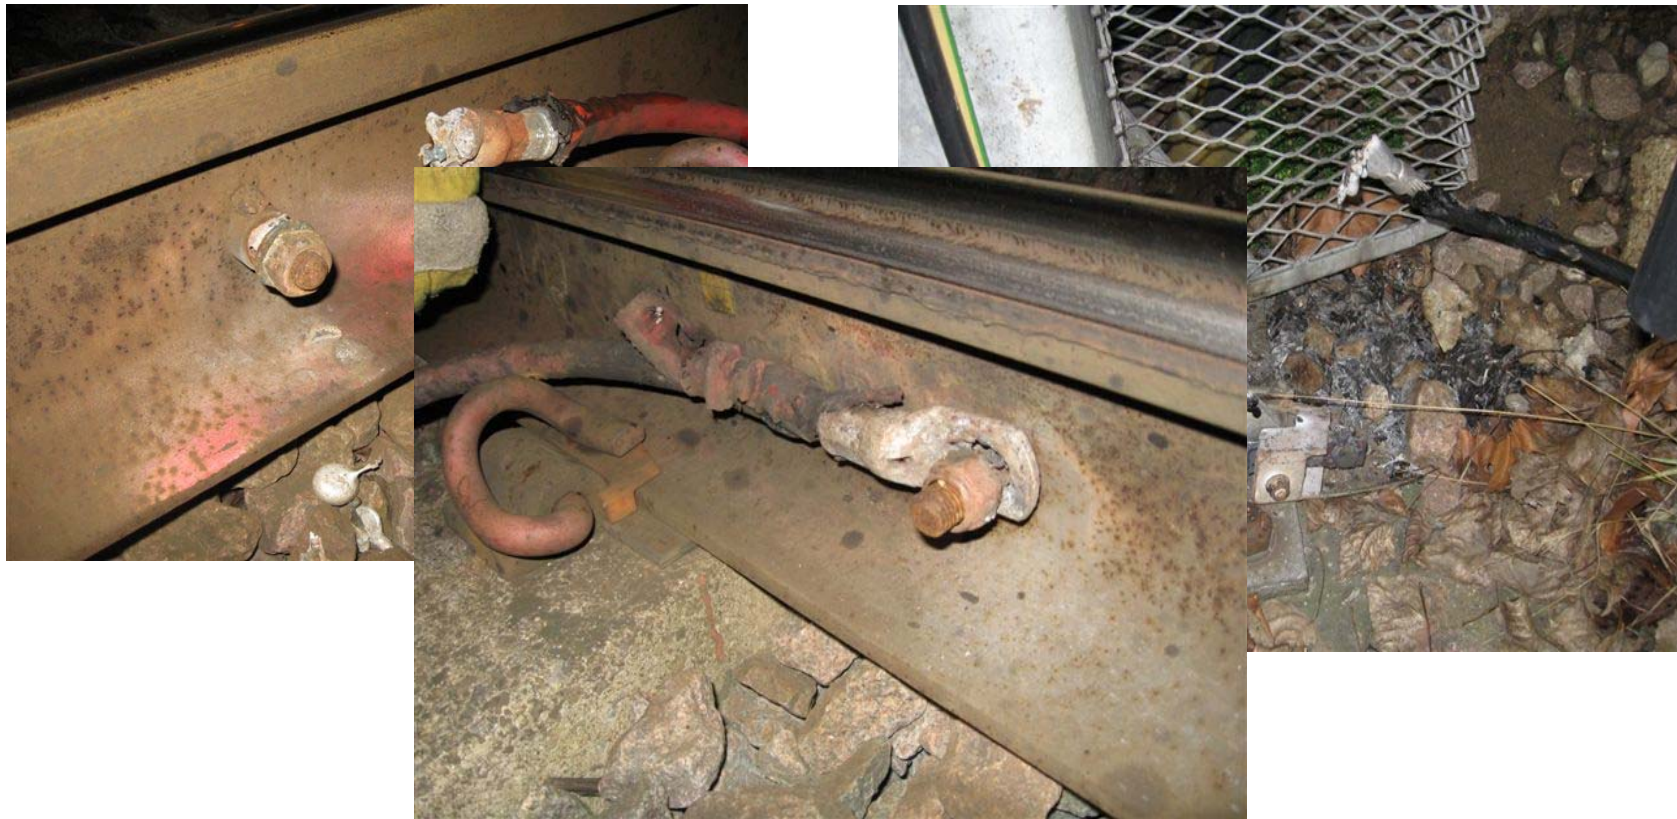
- Grahame Park bonding failure caused by Grid transformer failure at Borehamwood - operational issues in service reduction
